## **Neighbourhood Plan**

### **Footpaths and Active Travel Working Group**

#### **Working Group Report – March 2026**

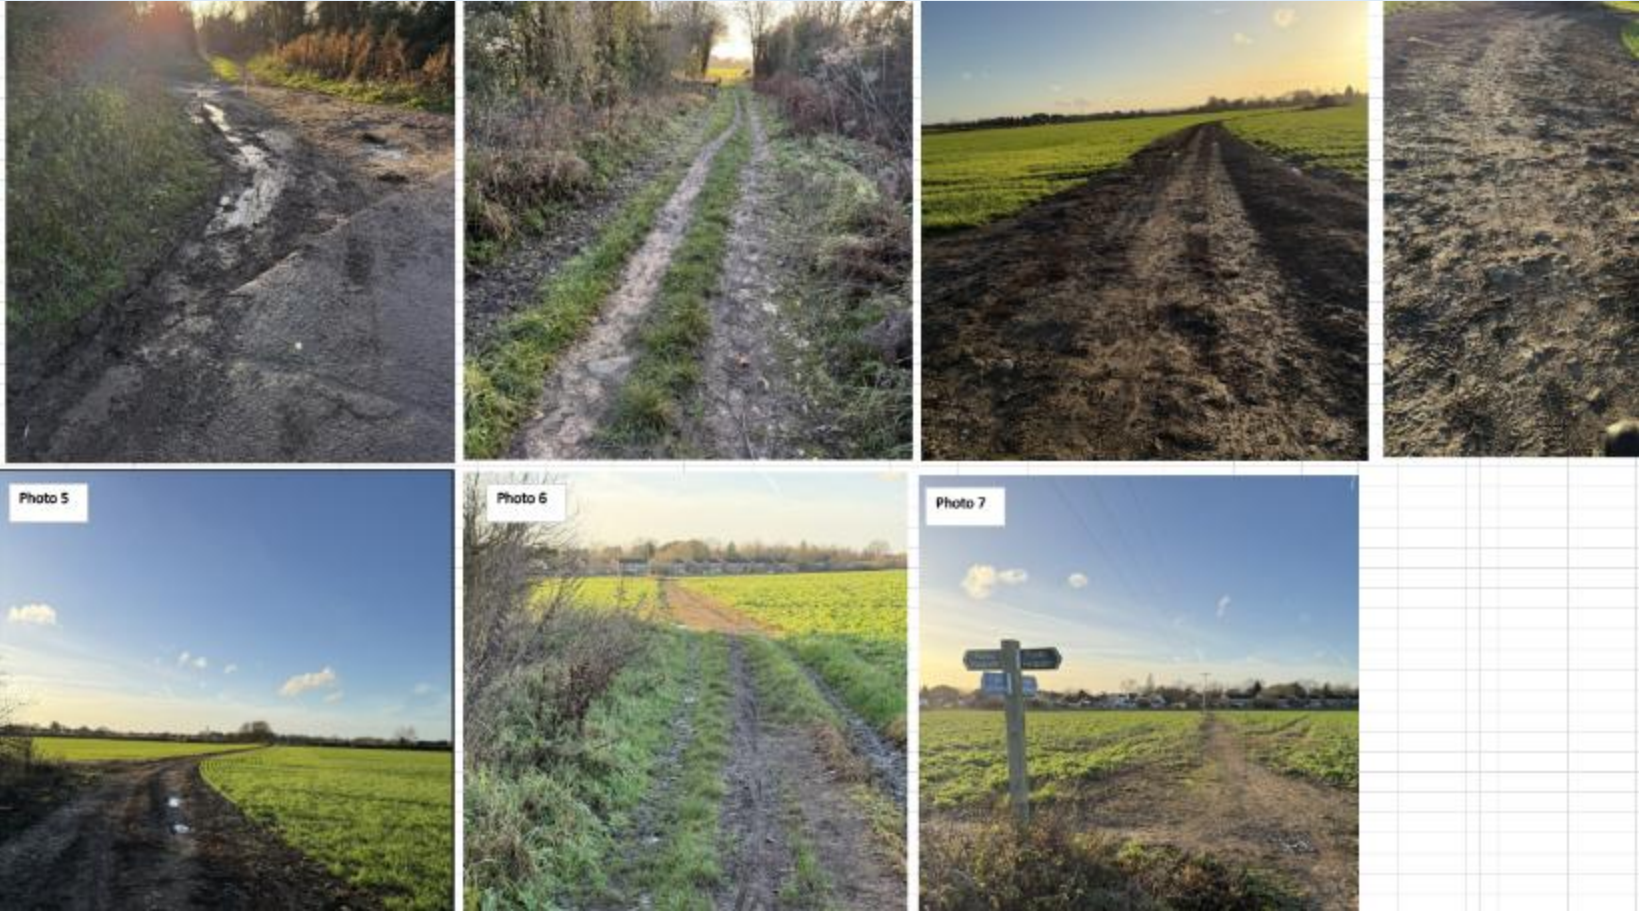
Bridleway from Dark Lane to Whitecross is a largely hardcore wide path with some mud sections. Large lengths used by farm vehicles so hardcore is muddy. At the end at Whitecross it ends at the Wootton Road where there is a footpath so people on foot can continue.

A bridleway connecting here to Wootton Village would be great to get from the parish to Wootton by bike.

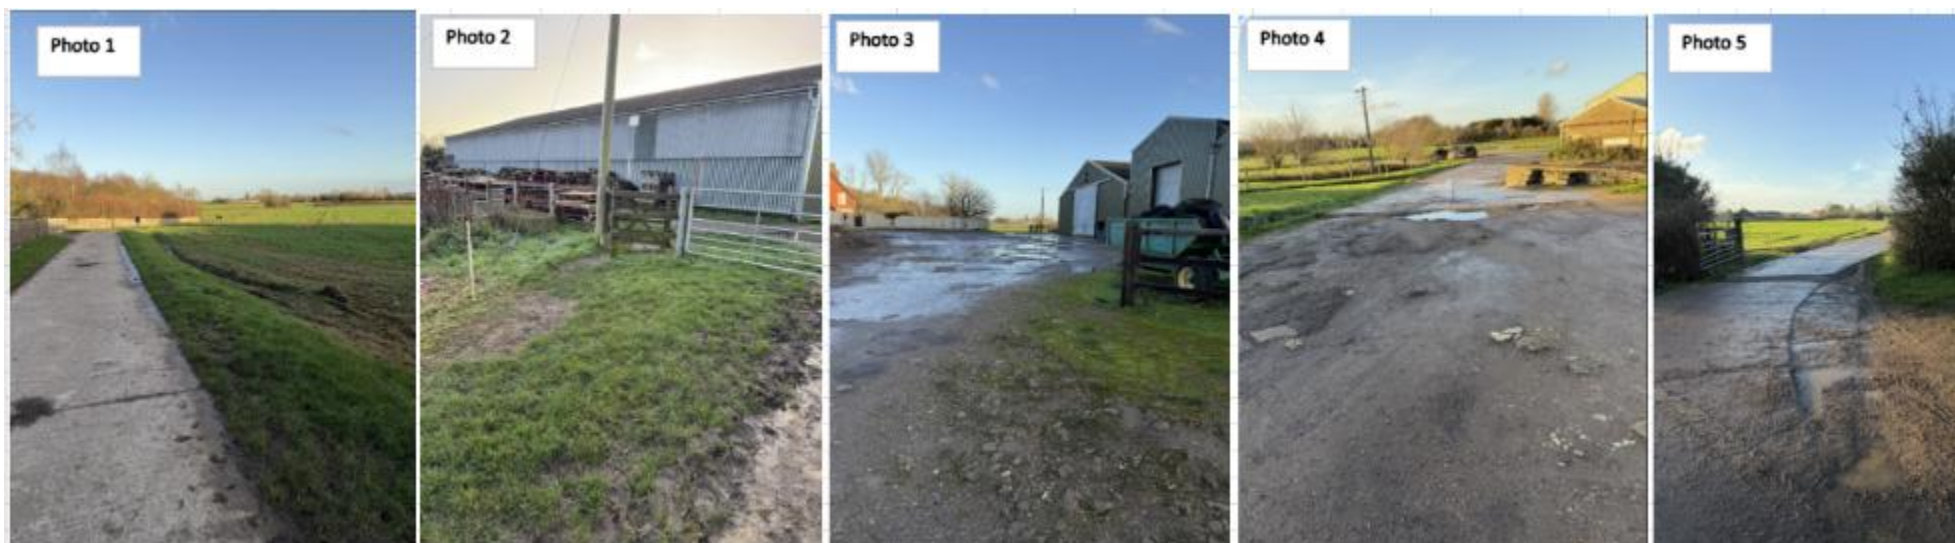
## Footpath 02

Once leaving the Cricket Field the footpath is entirely a concrete track that passes through a farmyard and then connects to the lower section of Foxcombe Road.

There is a single kissing gate to enter the farm yard. With the necessary investment this would make an ideal cycle route to bypass Foxcombe Road over Boars Hill and avoid going by road into Whitecross and then up to Wootton. As this is a working farm persuading the landowner to allow cycles would be necessary and may not be forthcoming on the basis of previous discussions.

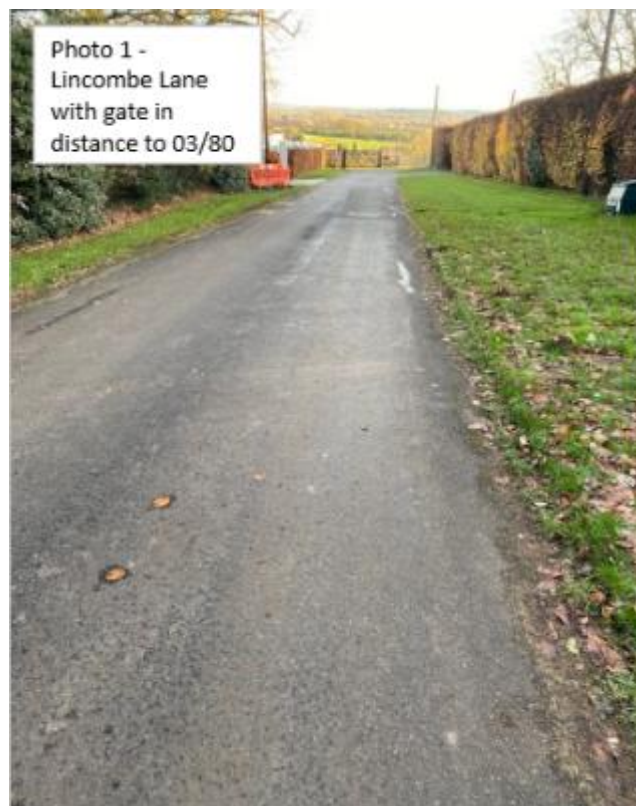
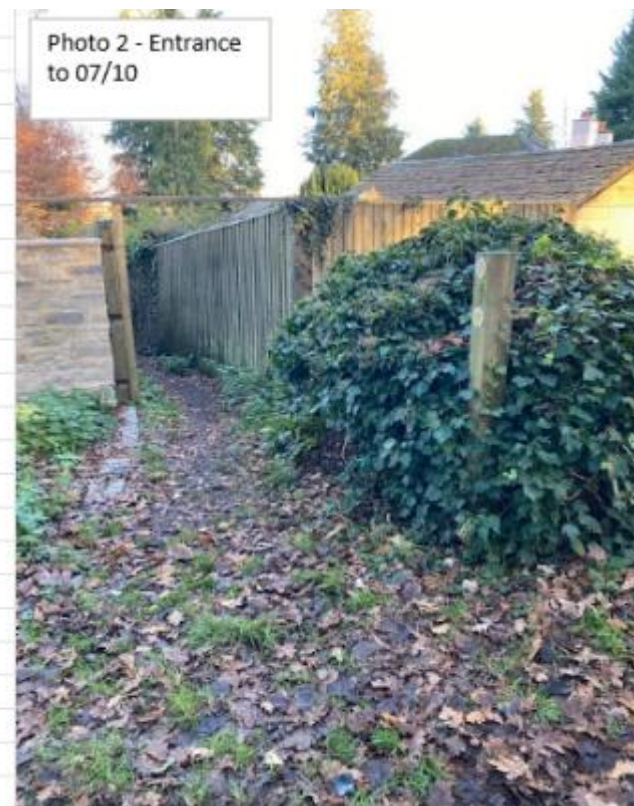
**Footpath 03/70**

This right of way connects footpaths 372/03/80 and 372/07/10 along Lincombe Lane. The surface is a made road.

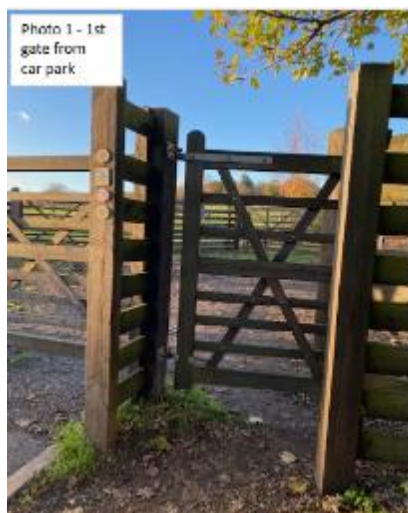
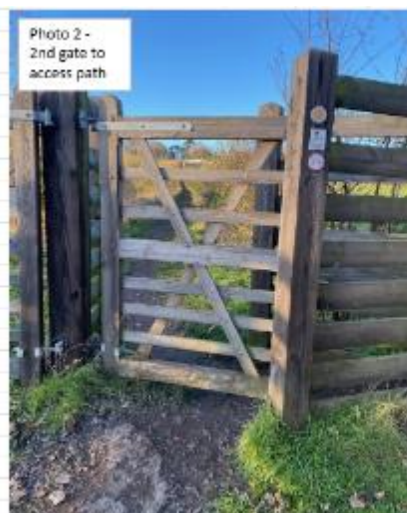
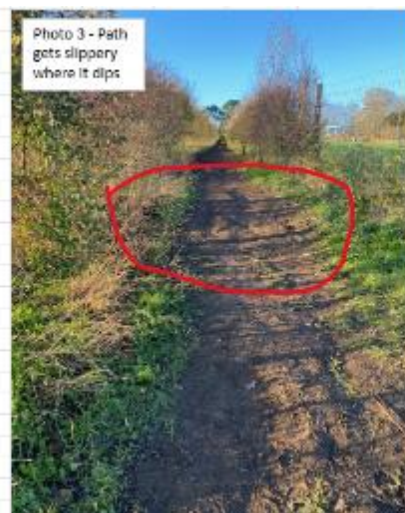
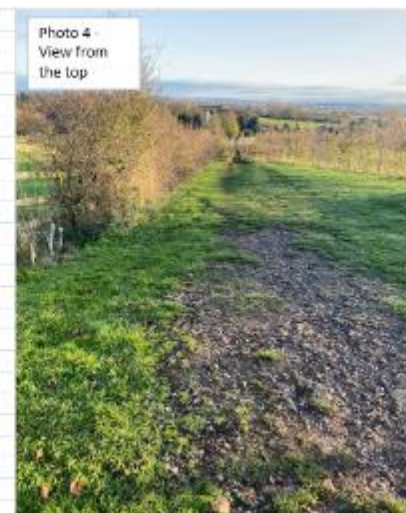
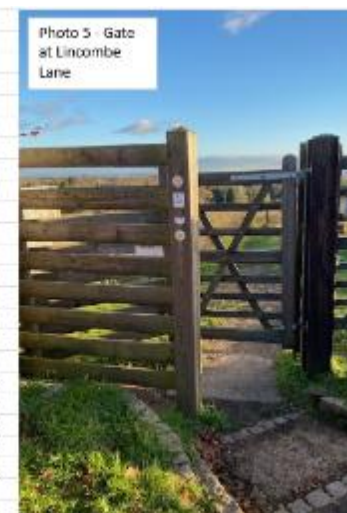
### Footpath 03/80

This right of way starts at the Sunningwell car park at the village hall, runs through the deer park fields up to Lincombe Lane. At the start there are two swing gates to access the path, at the Lincombe Lane end there is one swing gate. The surface is mud and uphill, at the midway point there is a dip in the ground which gets wet and slippery in the winter months. It's nice to see the deer in the fields enroute and a great view at the top of the path with a welcome bench.

- Footpath 3/80: this popular path (part of the Oxford Green Belt Way) connects Sunningwell Village with Boars Hill (Lincombe Lane). During winter its lower half becomes very muddy and would benefit from improved drainage and gravel, and at its mid-point would benefit from a couple of steps.
- Footpath 6/30: connects Bayworth Residential Park with Boars Hill (Lincombe Lane), becoming impassable in winter due to mud and its gradient. It would benefit from gravel, steps and improved drainage.
- Footpath 8/10, recently reinstated, has a short section on the spring line near the top which is a quagmire for most of the year. Previously an avoiding route through the field was used, but this is now prevented by the deer fencing, and improved drainage is required.

- Footpath 3/80: this footpath connects Lincombe Lane (private road providing access to Boars Hill and beyond) with Sunningwell village and is only approximately 300m. Tall gates, required to prevent access by farmed deer, makes the path virtually inaccessible to responsible cyclists wishing to wheel their cycles to Lincombe Lane.

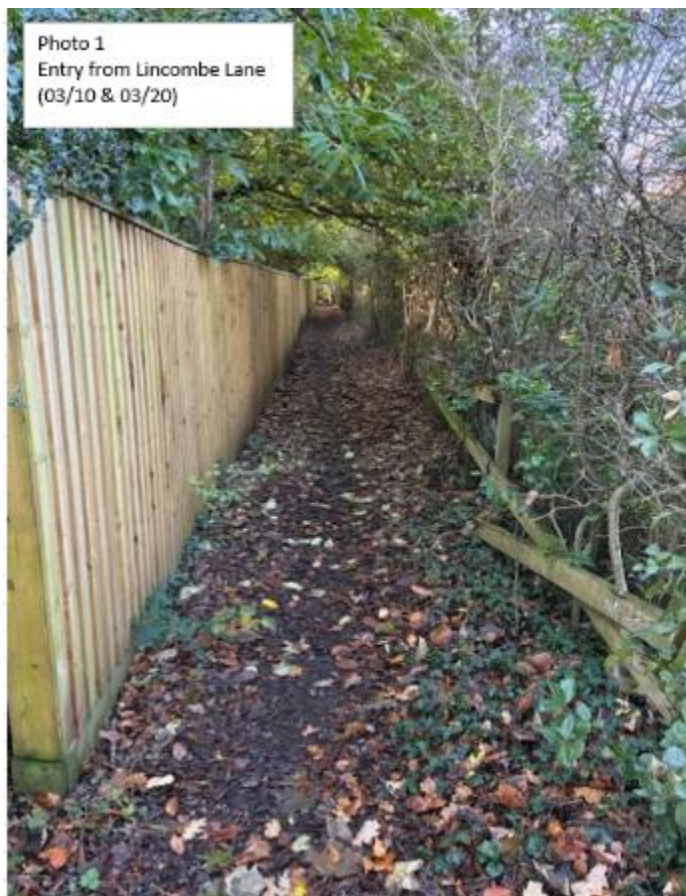
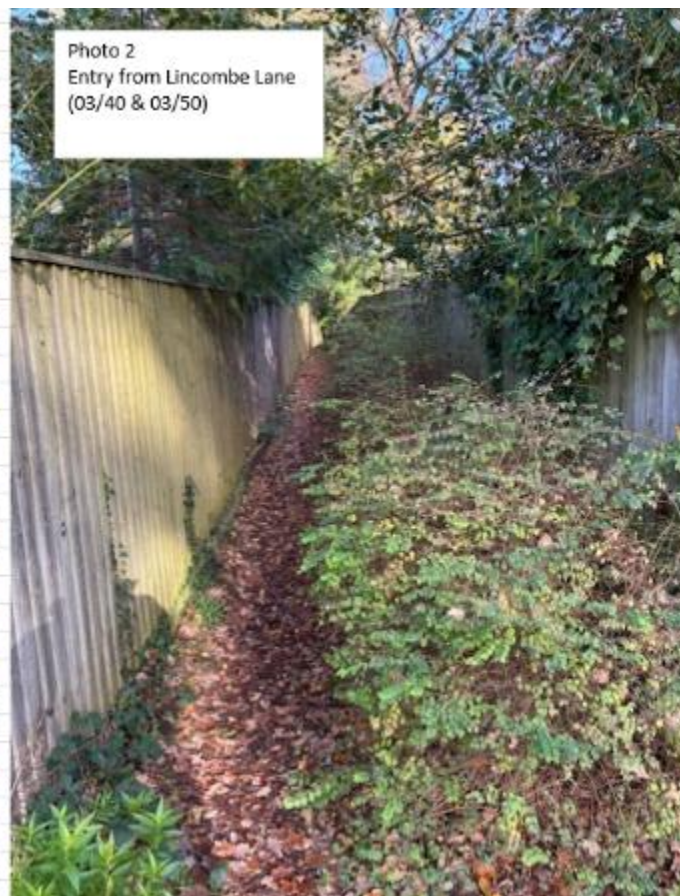
**Footpath 04**

This right of way (footpath) connects one part of Lincombe Lane (photo 1) to another (photo 2) behind the backs of houses, providing a shortcut. The entire length is bordered by garden fencing and is narrow (between 1.5m and 2.0m). Despite this terrain is good and not at all muddy.

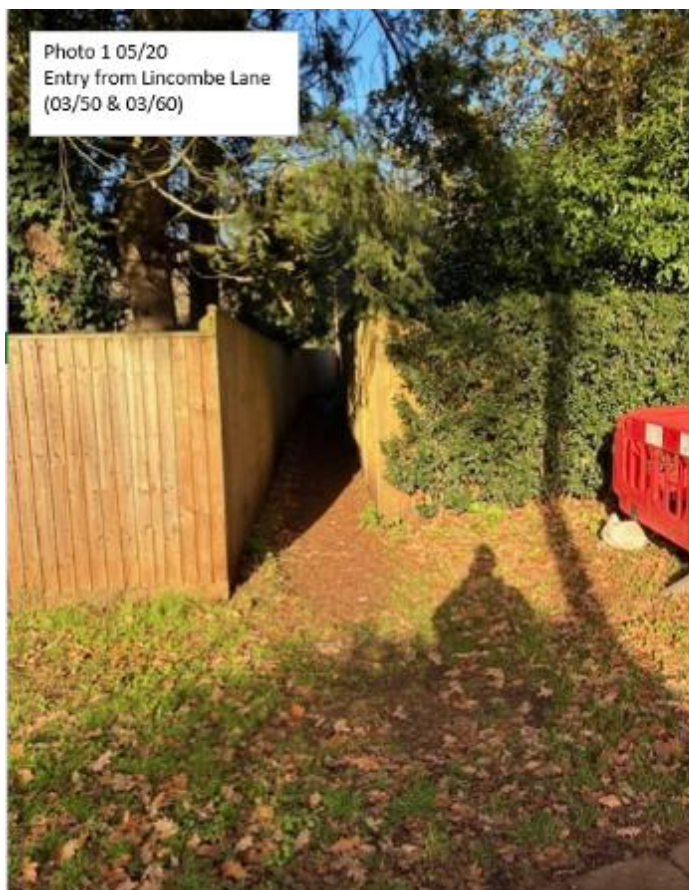
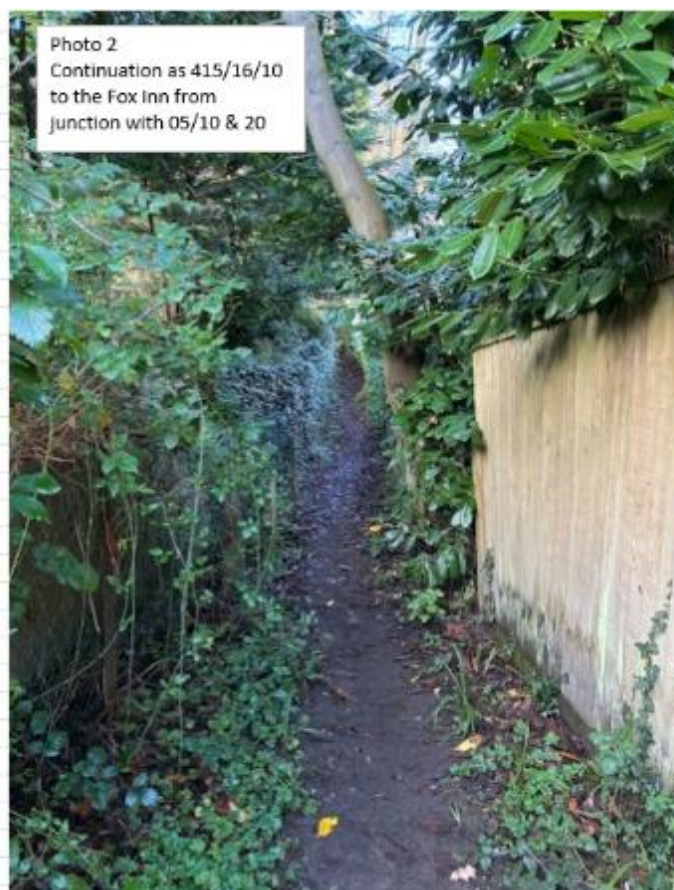
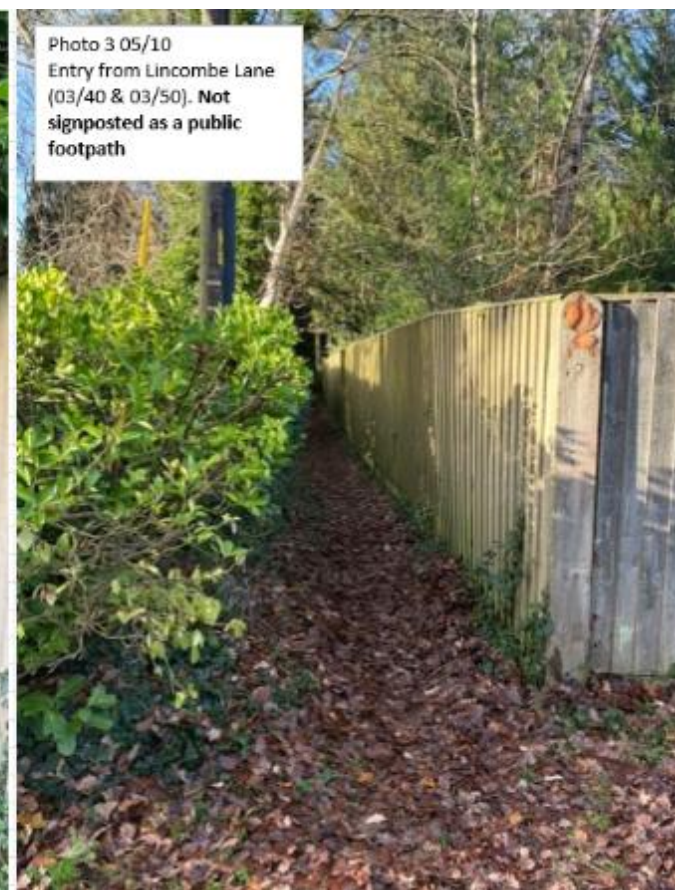
### Footpath 05

This right of way (footpath) connects one part of Lincombe Lane (photo 1) to another (photo 3) forming a dog-leg. At the apex of the footpath/dog-leg the path continues to the Fox Inn on Fox Lane as Wootton public footpath 415/16/10. This junction divides the footpath into its two halves 04/10 and 04/20. This continuation as 415/16/10 (see photo 2) to the Fox Inn (a local amenity) is at times quite muddy, but could relatively easily be remediated, albeit this section is outside Sunningwell parish. The entire length of 372/05/10 and 20 is bordered by garden fencing and is narrow (between 1.5 and 2 metres). Despite this, terrain in Sunningwell parish is good and not at all muddy.

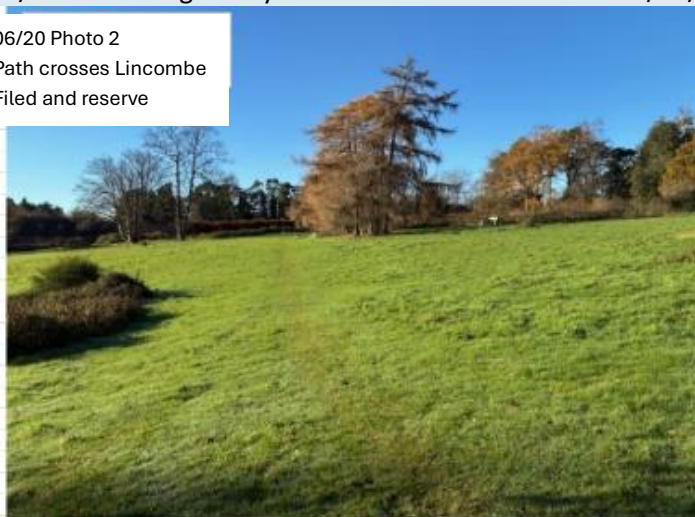
06/10 Photo 1

Entry from Lincombe Lane

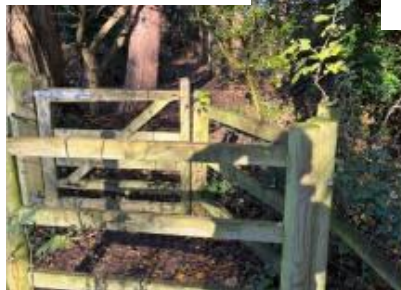
06/20 Photo 2

Path crosses Lincombe Field and reserve

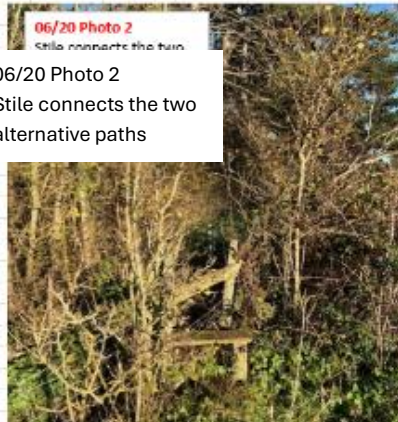
06/20 Photo 1  
Gate connecting with 18/10

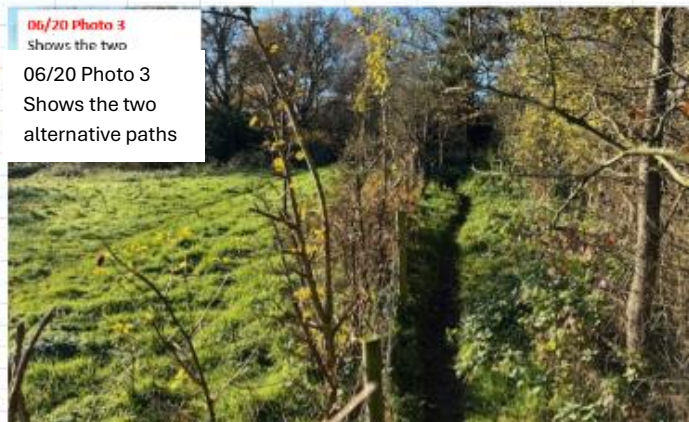
06/20 Photo 2  
Stile connects the two alternative paths

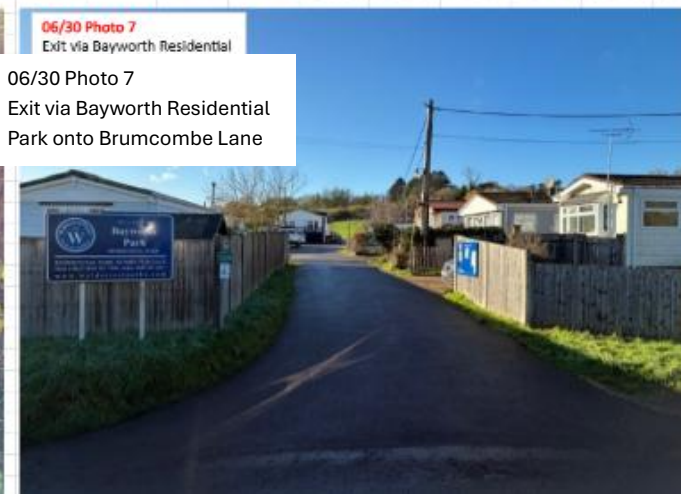
06/30 Photo 6  
A handy foot  
scraper is  
provided next  
to the bridge

A foot scraper has been provided by the residents on footpath 6 on entry to Bayworth Residential Park to reduce the amount of mud being walked on the road in front of their houses.

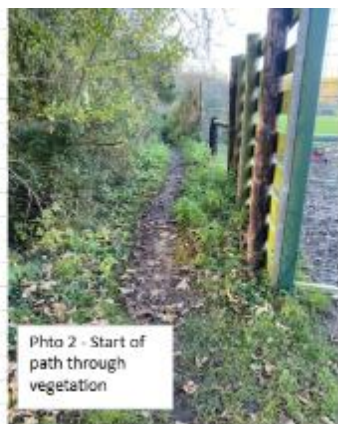
This right of way runs from the Bayworth end of Sunningwell Road to Lincombe Lane. At Sunningwell Road there is a stye and also a gap for access, the path crosses a culvert then an area of thick vegetation, often overgrown with brambles and nettles. The path then widens out and you walk between the wire fencing of the deer park fields with good visibility in both directions. Mid-way there is a point where the deer can cross the footpath to access other fields, this gets muddy in winter. At the top of the fields the path veers to the left, across a wooden bridge over a brook (improvements needed as handrail has collapsed) then narrows between wooden fencing of two properties, (to 85cms in some places), the path then emerges onto Lincombe Lane.

Photo 1 -  
Entrance from  
Sunningwell Road

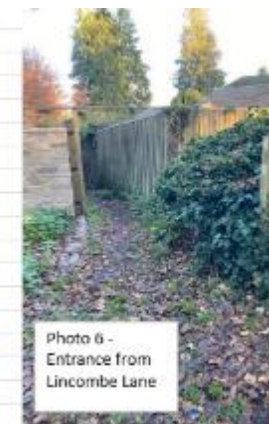
Photo 5 - path  
narrows  
between  
wooden fencing

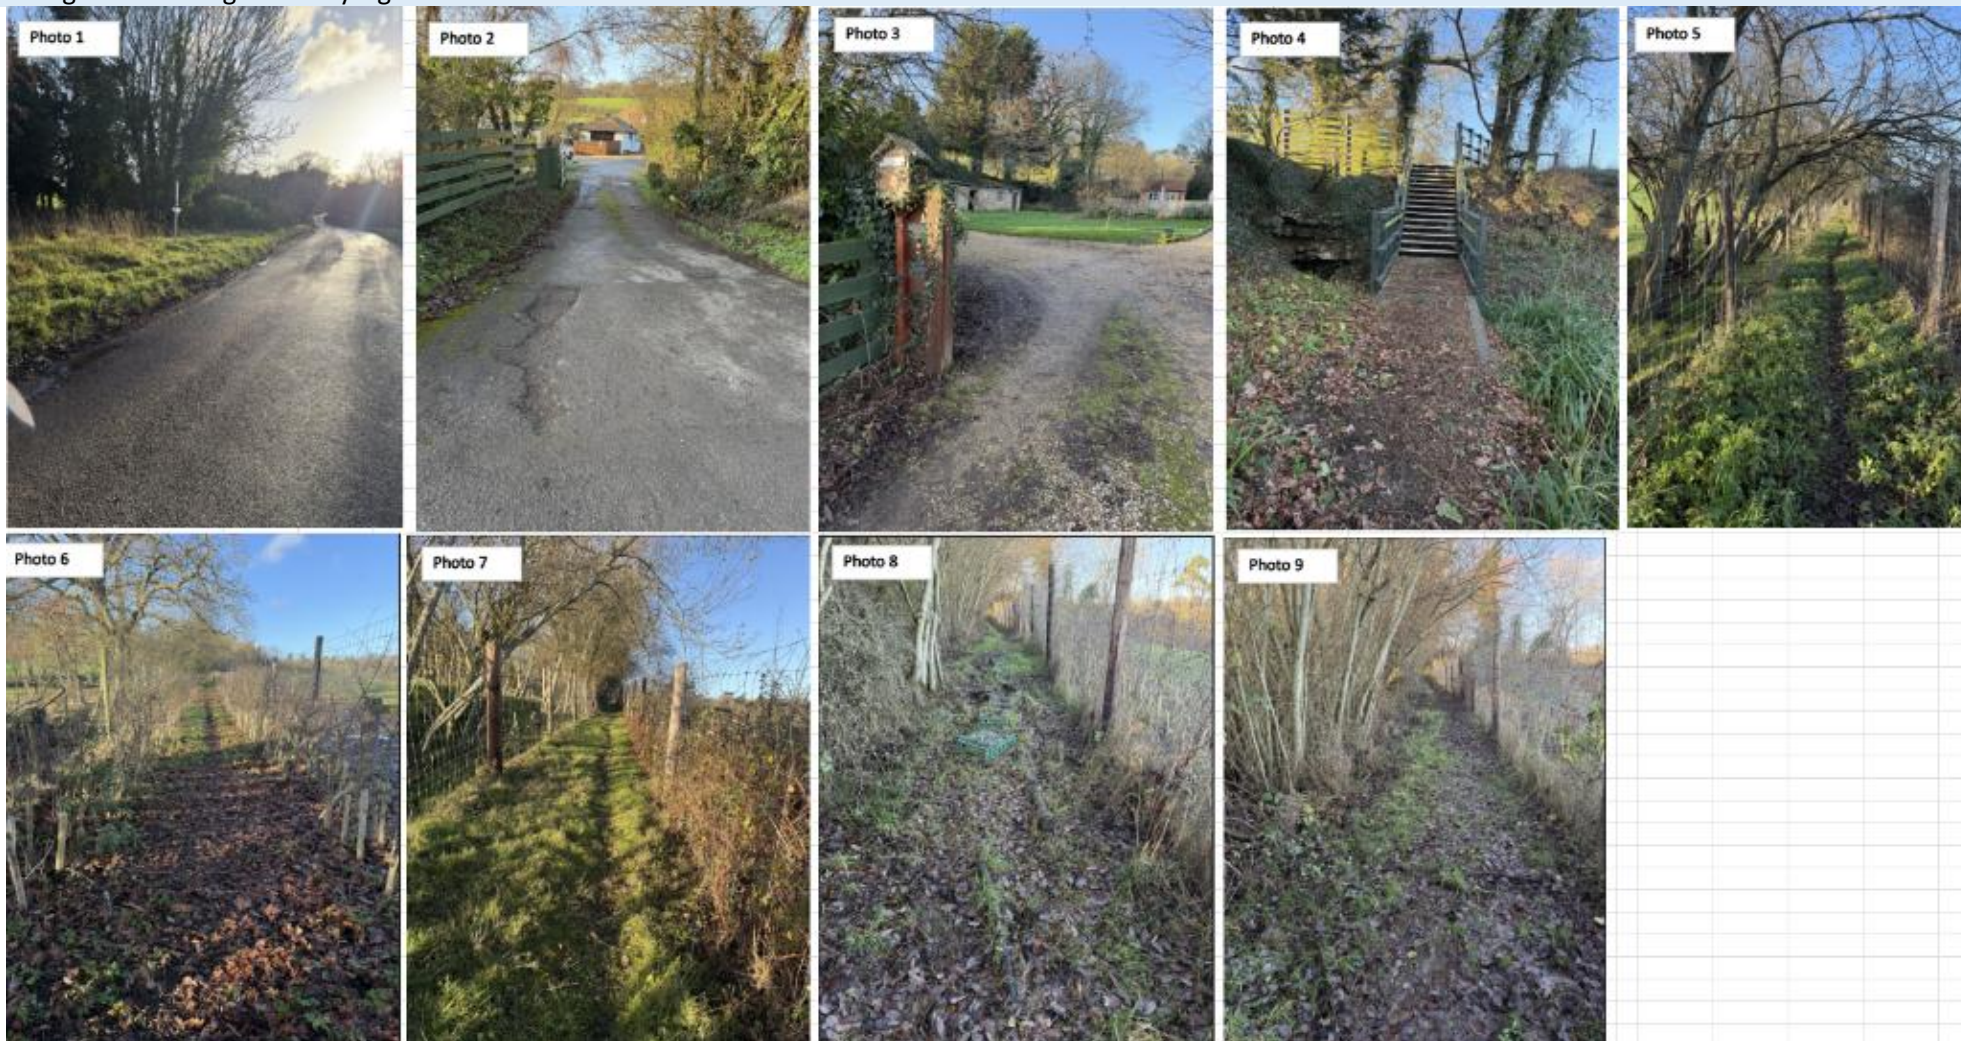
Photo 6 -  
Entrance from  
Lincombe Lane

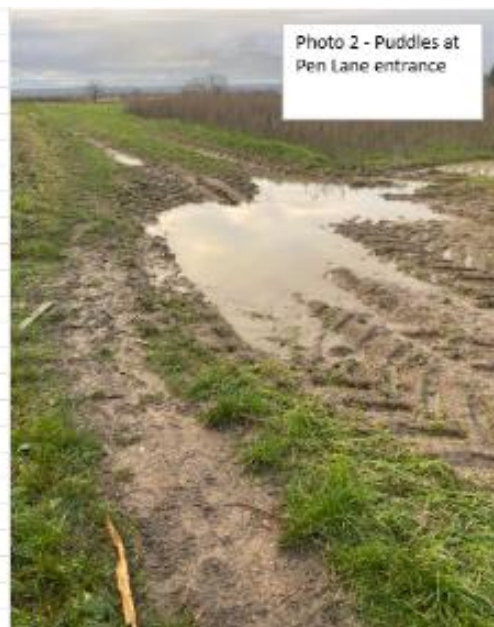
This right of way is the most direct path from Bayworth to Abingdon and would be well used if conditions permitted. It starts on the road connecting Sunningwell with the Oxford Road Church Lane opposite the junction with Green Lane, follows along an agricultural field and connects with the junction of 372/13/10 and 20. The surface is mud, both ends and the middle of the path are prone to large puddles and slippery due to the use of the farmers tractor.

Photo 1 - Pen Lane entrance

- Footpath 12: connects Bayworth/Green Lane to Pen Lane (and beyond to North Abingdon) and is popular with cyclists, presenting two possible options, either it could have, 1, gates added to its entry points to deter cyclists or 2. be widened and improved as a bridleway/cycleway.

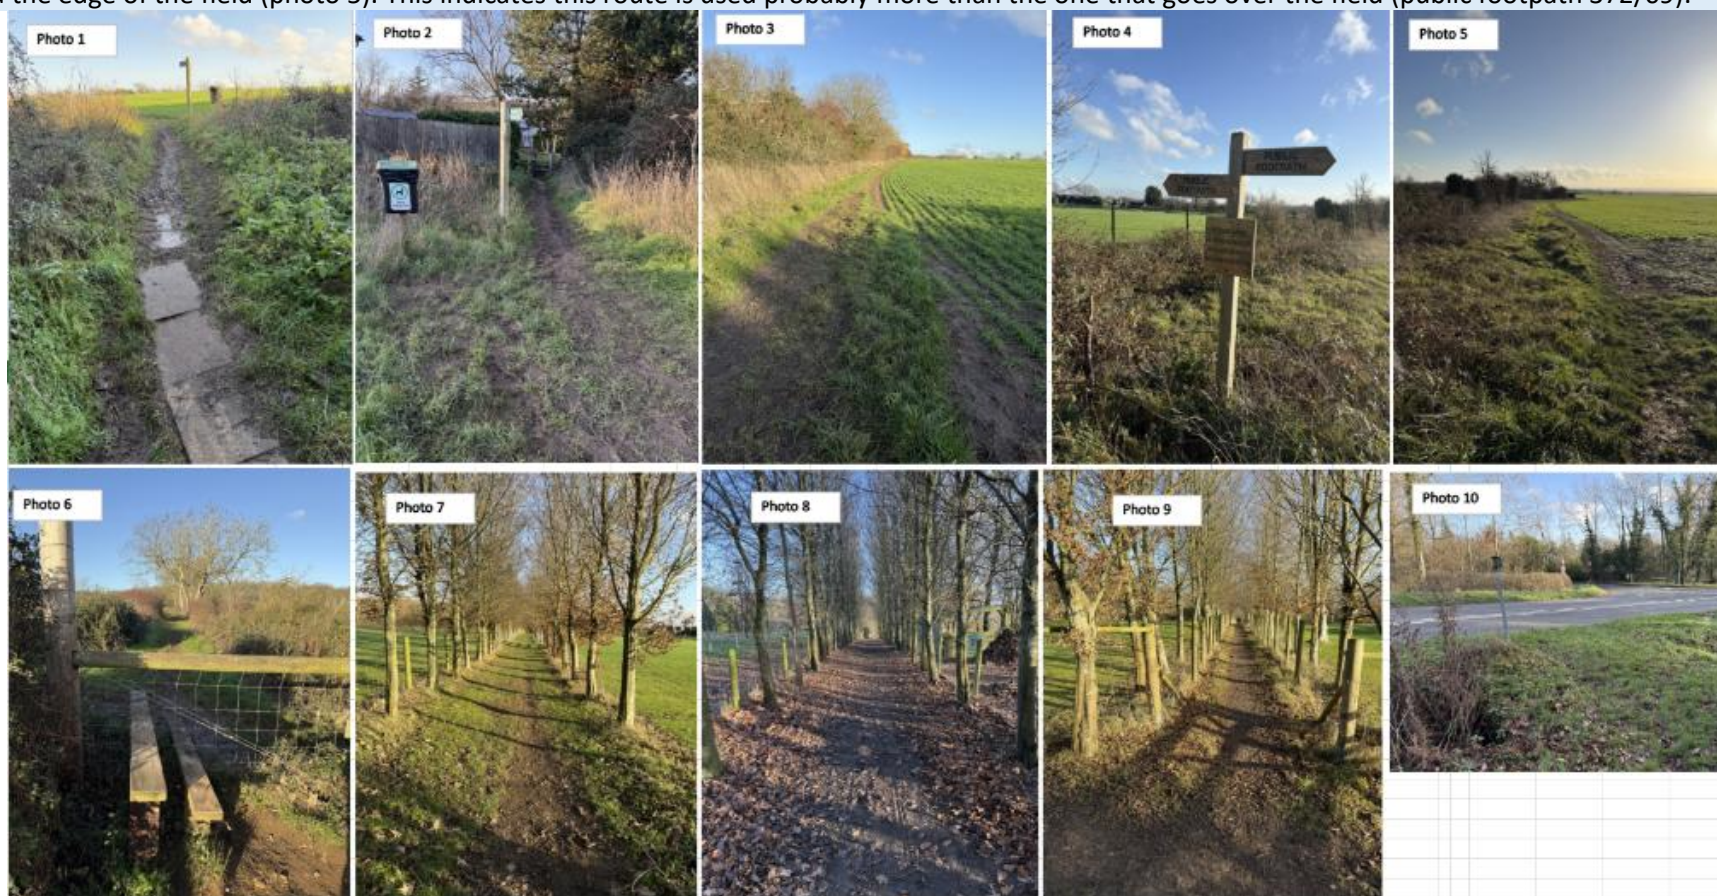
## Bridleway 13

The part of the bridleway we are concerned with covers the way from the bridge over the A34 to Beaulieu Court. Most of this is tarmacked although nearer Beaulieu Court the tarmac was removed by the tenant farmer. The farmer maintains the verges from 372/13/10 – 372/13/20 but nothing is maintained from the slope to the bridge which might be under the care of the County Council. From the photos you can see that despite relatively recent repairs the tarmac is splitting and the verges are narrowing the way. The steps leading to footpath 372/11/20 are dangerous after rainfall.

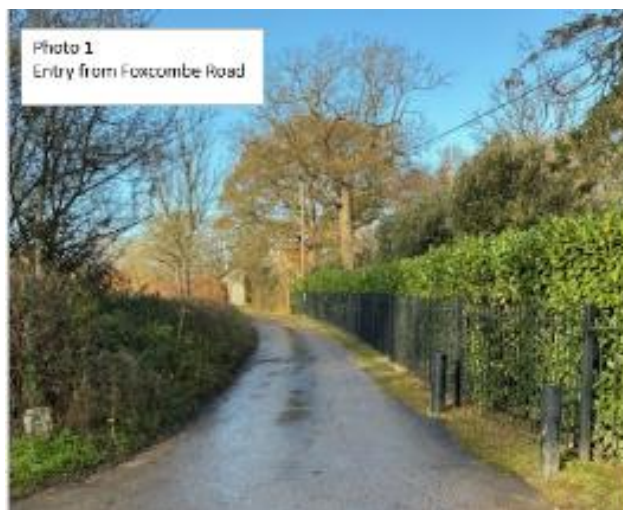
## Bridleway 16

This right of way connects Foxcombe Road (photo 3) initially (approximately 100m) behind the backs of gardens and the dense scrub (photo 2) at the edge of the old golf course, followed by 100m on the edge of woodland bordering the old golf course, before exiting to an open field (OPT) at the foot of the old golf course (photo 1). This section of the right of way was fit for purpose as footpath but not as bridleway. Without use it would be vulnerable to becoming overgrown and in very wet weather impassable.

The path continues through an open field (photo 4), from where it enters Cumnor parish, towards Chilswell Farm. Although not public rights of way, there are much more popular and passable footpaths which connect through the old golf course only 50m further along the Foxcombe Road, albeit these are not used or suitable for horses.

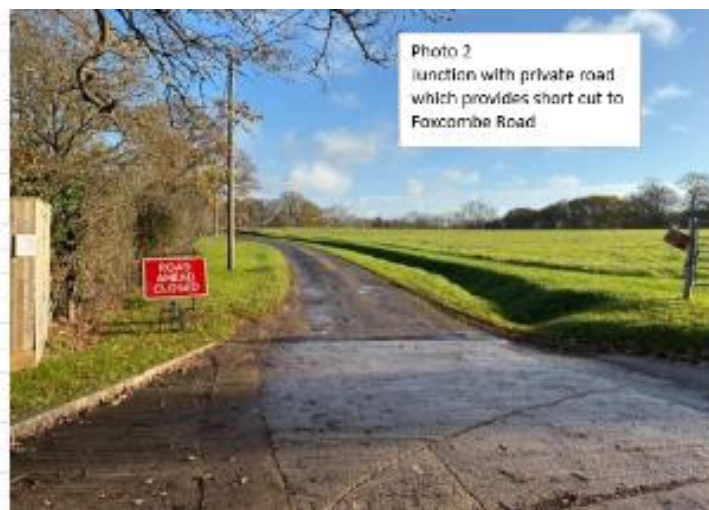
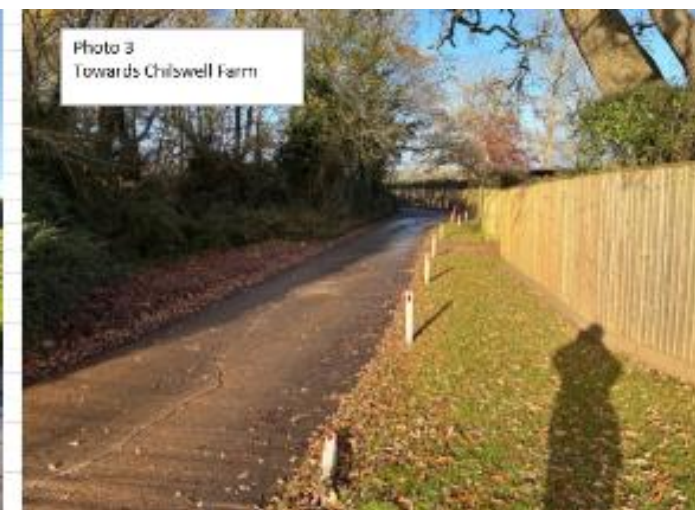
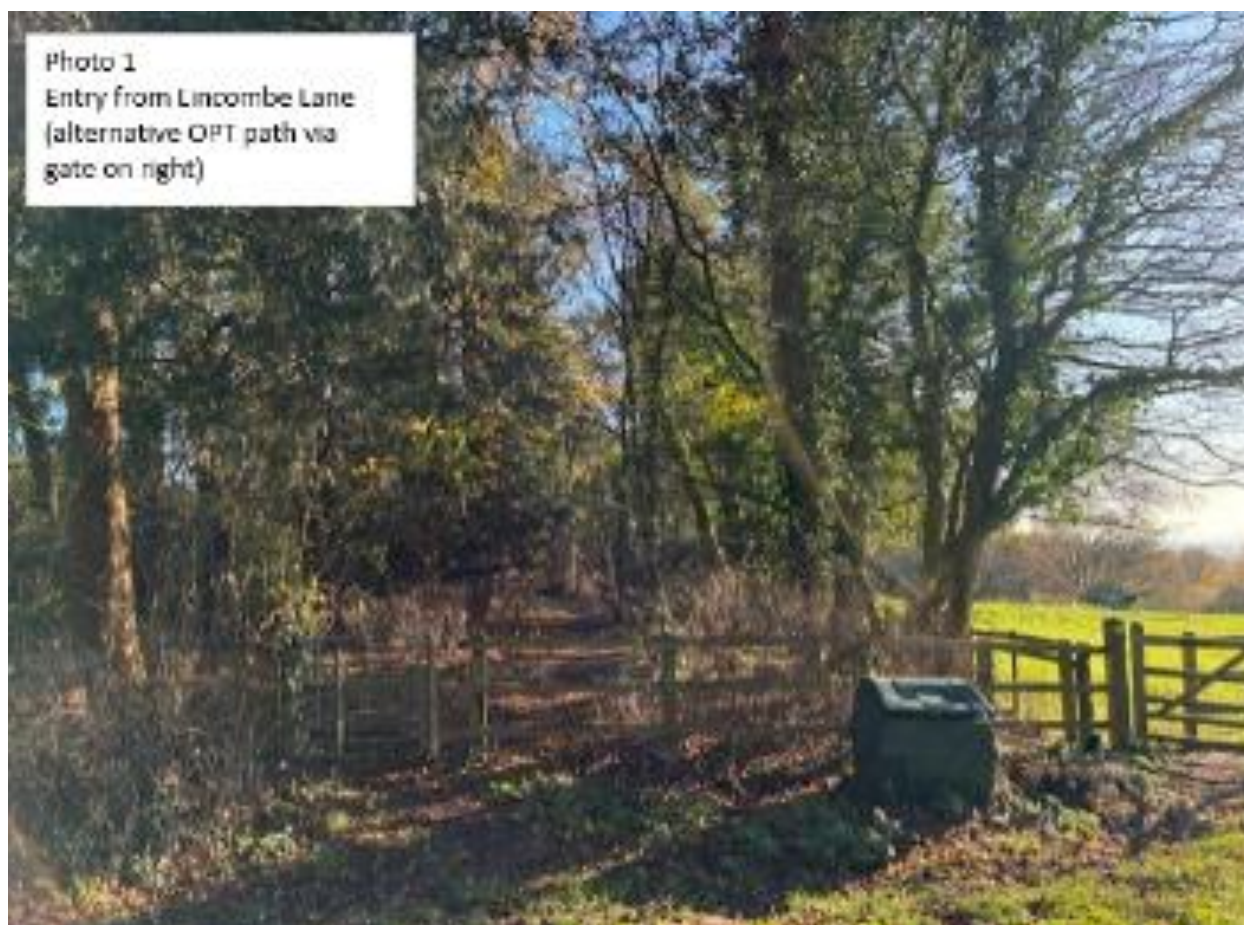
### Bridleway 17

This right of way (bridleway) connects Foxcombe Road (photo 1: entry from road) near the Hinksey Hill junction with Chilswell Farm (Cumnor parish). The bridleway is mainly tarmac as it doubles up as an access road for a number of properties including Chilswell Farm. It connects to another private road (at junction of photos 2 and 3) which acts as a shorter route for vehicles from Chilswell Farm accessing the Foxcombe Road.

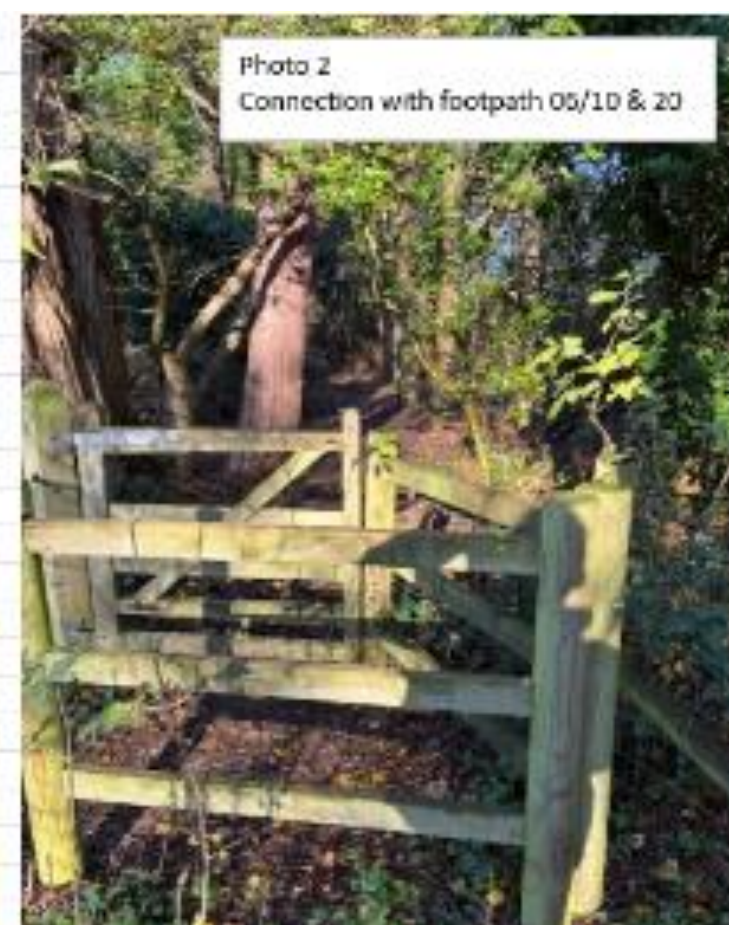
### Footpath 18

This short (110m) right of way (footpath) begins on the corner of Lincombe Lane (photo 1) and connects with footpath 372/06/10 and 20 (see photo 2 for the connecting point). The path is lined on either side by trees and is relatively good condition (i.e. not too muddy). It is bordered by OPT-owned Lincombe Field and Reserve and Foxcombe Hill Farm.

As photo 1 illustrates, an alternative footpath is provided by the OPT entering Lincombe Field and Reserve via gate, which also connects with 372/06/10 and 20. This is not a public right of way.
